## City Of Fairfax Washout Inspection Report

### Tank Information for Customer #5533

- **Tank Name:** University Tank
- **Tank Size/Style:** 4,000,000 Standpipe
- **Tank Location:** University Campus
- **Project Number:** 110259
- **Service Request:** 359279
- **Inspection Date:** December 28, 2012
- **Report Author:** Chris Palmer
- **Inspected By:** Timothy Clark

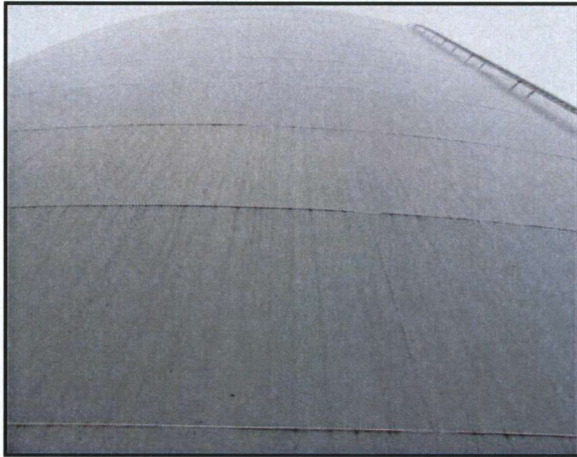
- Interior Coating Condition: The interior coatings were not inspected but will be at the next interior inspection, cleaning and disinfection.
- Exterior Coating Condition: Exterior coating is in good condition.
- Dry Interior Condition : The interior coatings were not inspected but will be at the next interior inspection, cleaning and disinfection.

Exterior

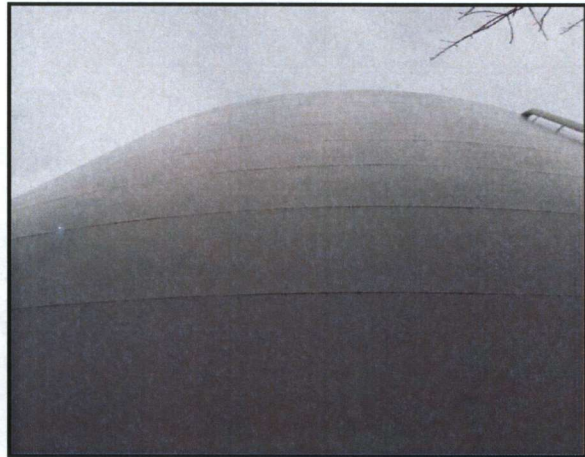
Exterior

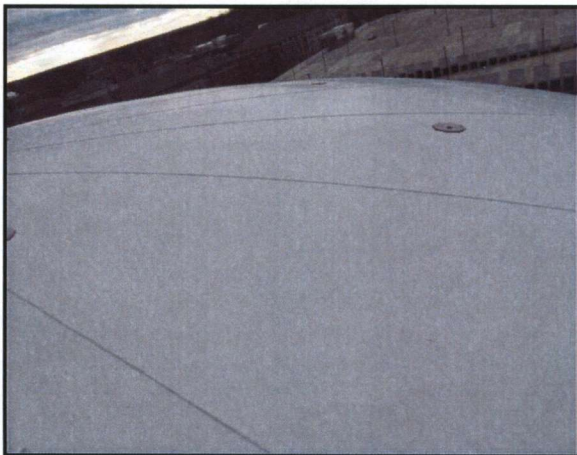
Exterior

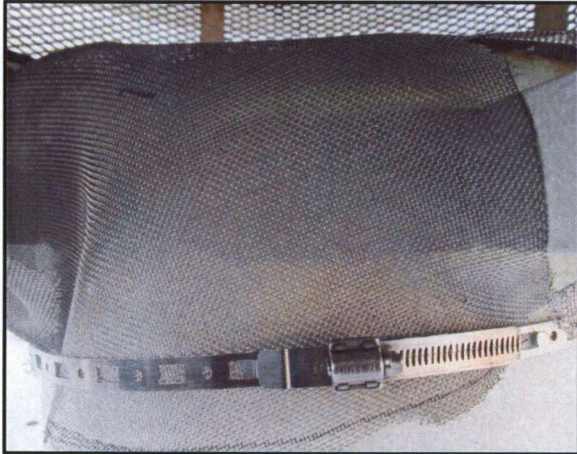
- Safety Climbing Devices: Ladders are equipped with secured safety climb devices.
- Access Hatch1: Good
- Access-Hatch2: Good
- Vent Screen: Vent screen was replaced at the inspection.
- Evidence Of Foreign Matter: The interior was not inspected.
- Sediments: The interior was not inspected.

Roof vent screen

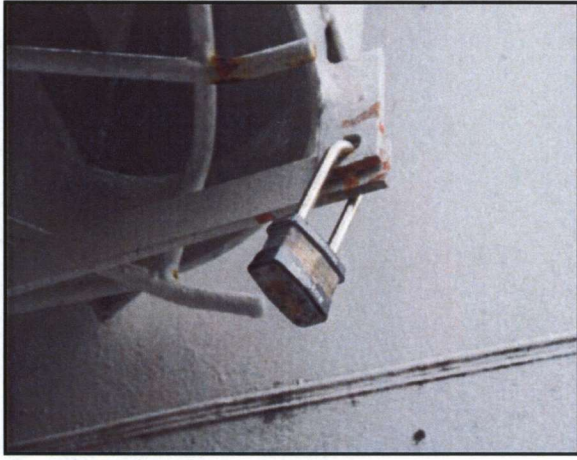
Ladder gate locked

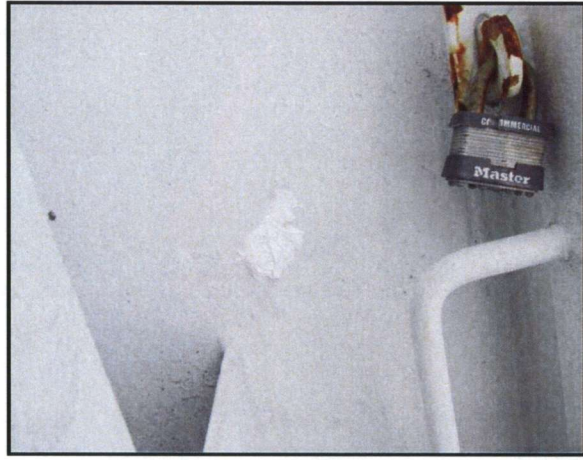
- Fence Around Site: Tank is located inside a fenced-in area.
- Access Hatch Locked: Access Hatch is Secured.
- Evidence Of Vandalism: There is not evidence of vandalism.

Roof access hatch locked
